DS150 - MANITEX
For Truck Mounted Cranes

Service Manual

SYSTEM DESCRIPTION

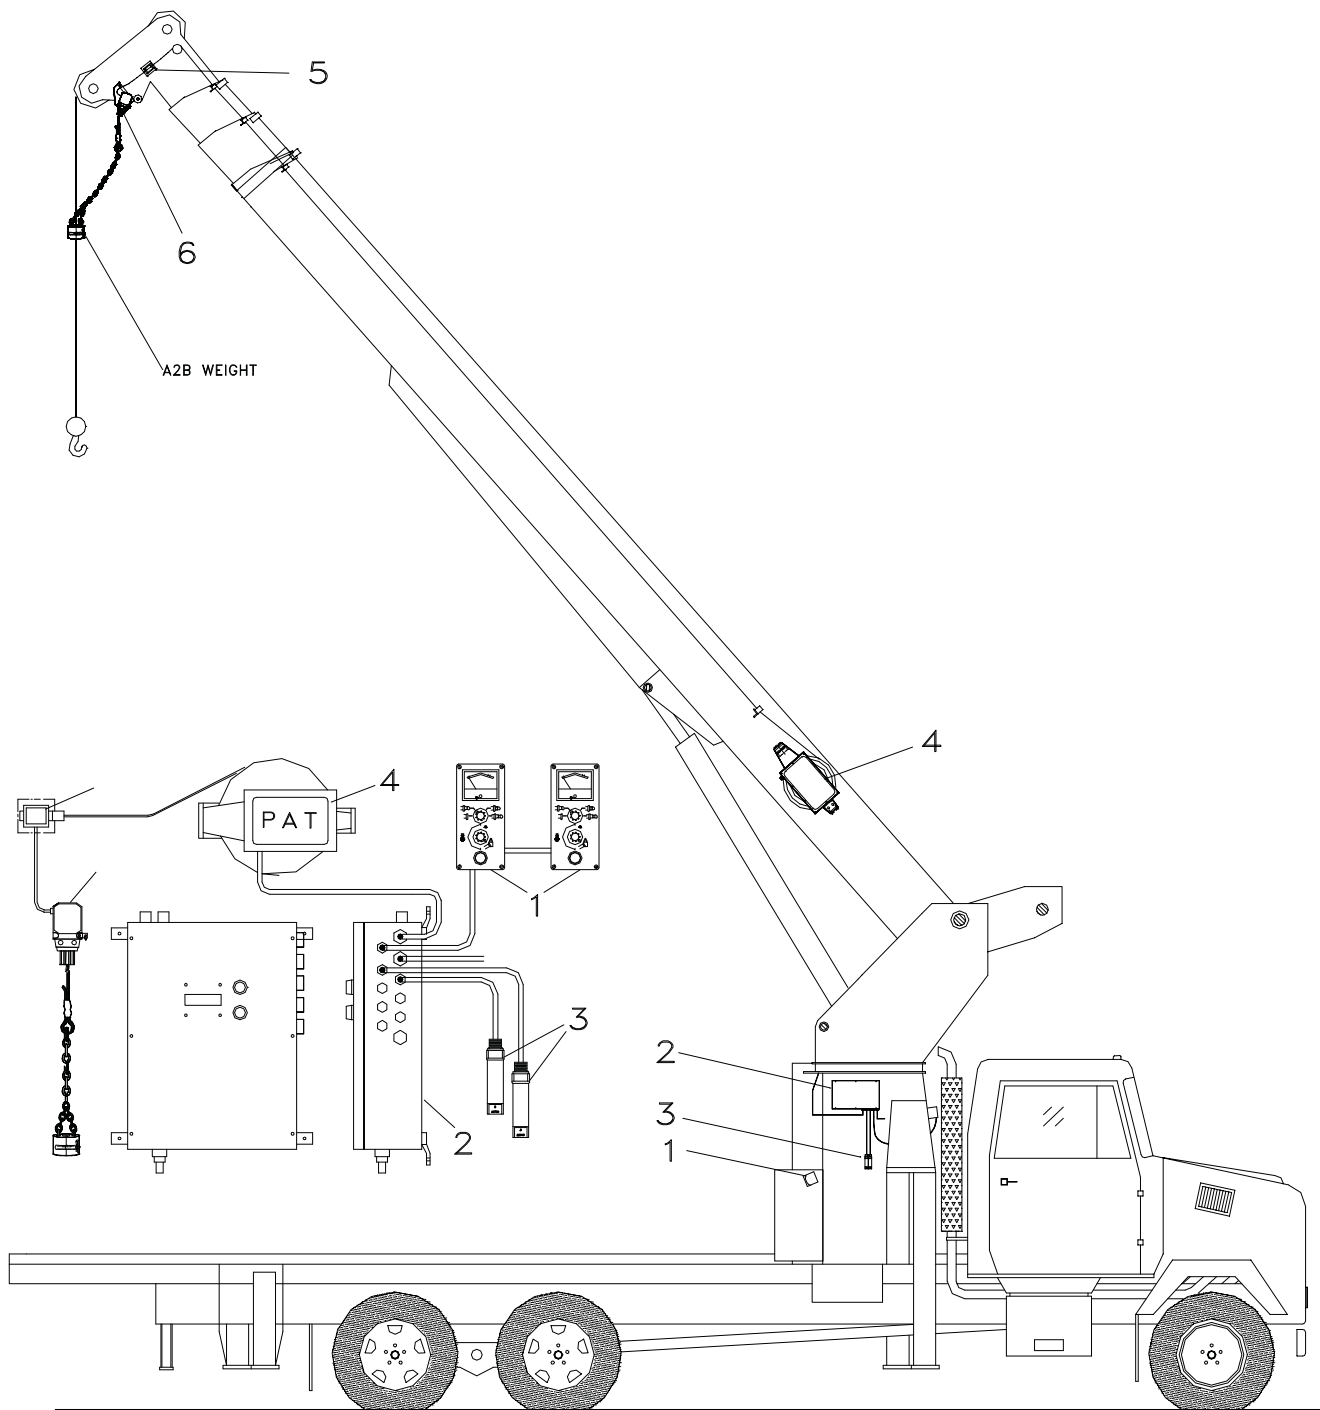
Fig. 1: Components of the LMI System PAT DS 150

1. Operator's Console
2. Central Unit
3. Pressure Transducer
4. Cable Reel
5. Boom Tip Junction Box
6. A2B Switch

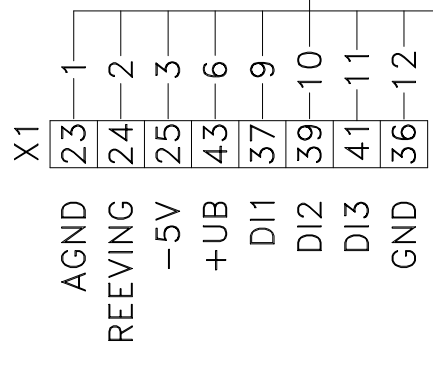
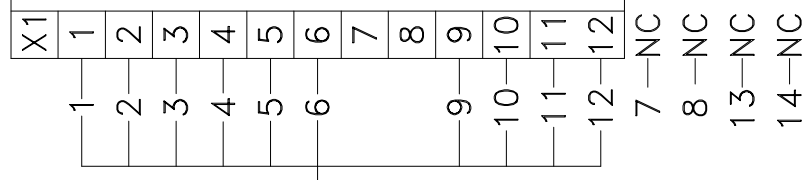
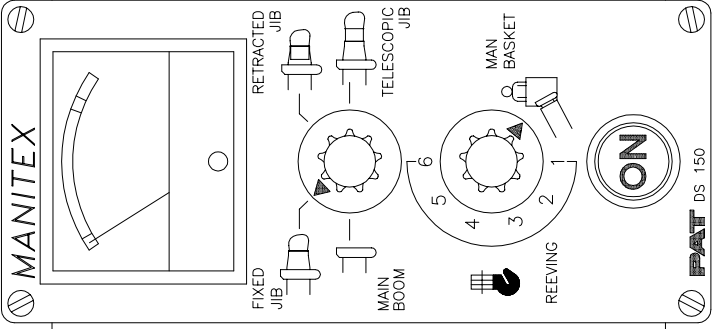
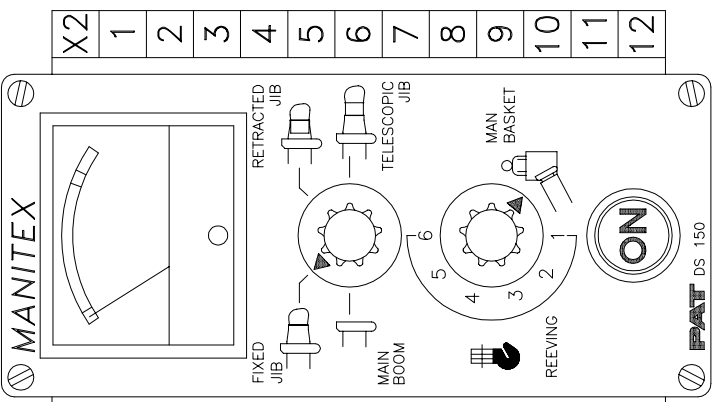
DS150 CENTRAL UNIT

74" OF 14 X 0.5 CABLE HARDWIRED TO 031-300-100-842 CONSOLE,
 PLUG OTHER HOLE IN BACK OF CONSOLE. MANITEX WIRES OTHER
 CONSOLE 050-000-060-045 AND CENTRAL UNIT 024-150-060-002.

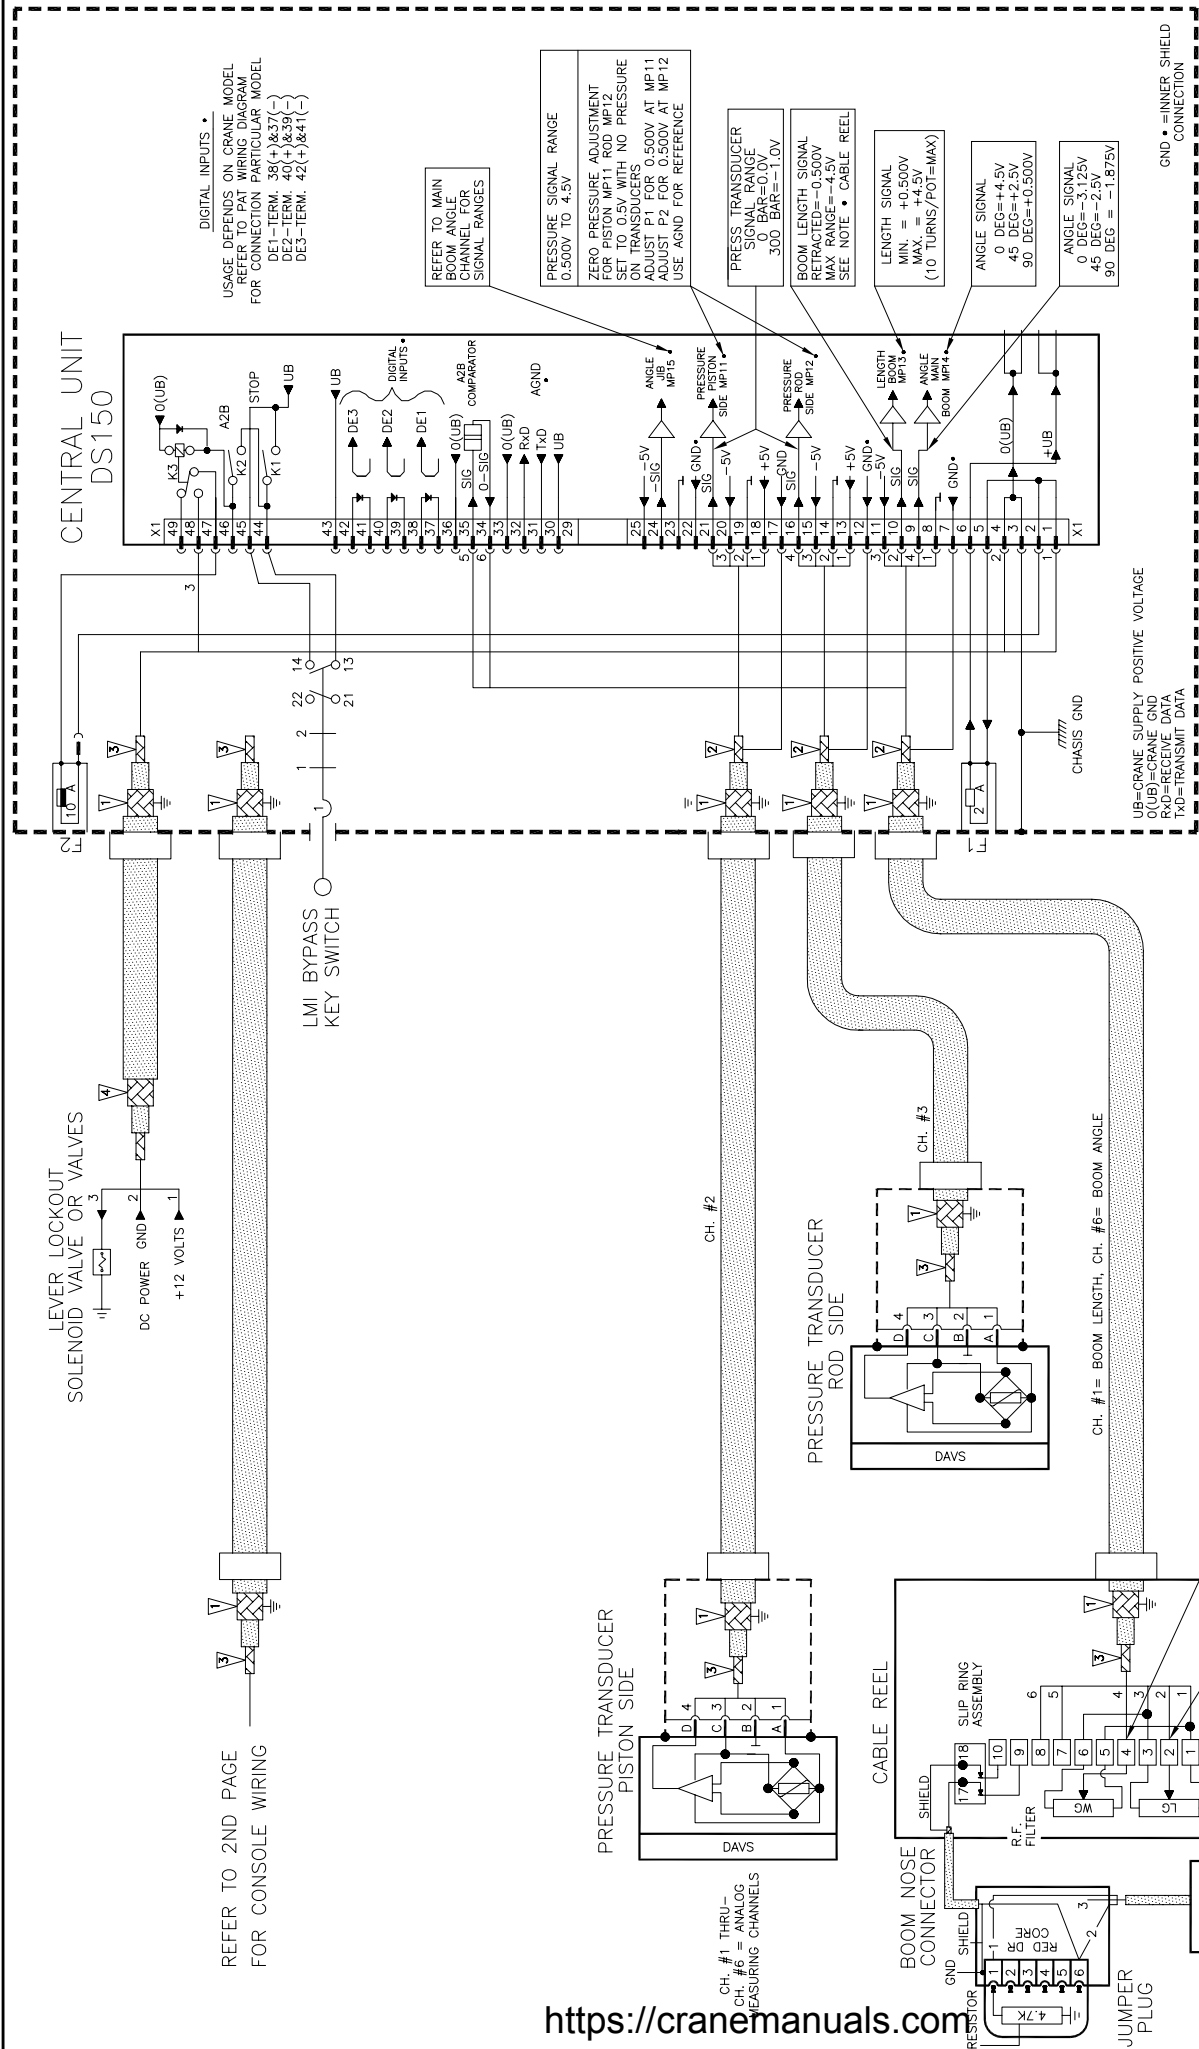
DIGITAL INPUTS •
 USAGE DEPENDS ON CRANE MODEL
 REFER TO PAT WIRING DIAGRAM
 FOR CONNECTION PARTICULAR MODEL
 DE1-TERM. 38(+)&37(-)
 DE2-TERM. 40(+)&39(-)
 DE3-TERM. 42(+)&41(-)

REFER TO MAIN
 BOOM ANGLE
 CHANNEL FOR
 SIGNAL RANGES

PRESSURE SIGNAL RANGE
 0.500V TO 4.5V
 ZERO PRESSURE ADJUSTMENT
 FOR PISTON MP11 ROD MP12
 SET TO 0.5V WITH NO PRESSURE
 ON TRANSDUCERS
 ADJUST P1 FOR 0.500V AT MP11
 ADJUST P2 FOR 0.500V AT MP12
 USE AGND FOR REFERENCE

PRESS TRANSDUCER
 SIGNAL RANGE
 0 BAR=0.0V
 300 BAR=-1.0V
 BOOM LENGTH SIGNAL
 RETRACTED=-0.500V
 MAX RANGE=-4.5V
 SEE NOTE • CABLE REEL

LENGTH SIGNAL
 0 DEG = +0.500V
 MAX = +4.500V
 90 DEGS/POT=(MAX)
 (10 TURNS/POT=MAX)

ANGLE SIGNAL
 0 DEG=+0.500V
 45 DEG=+2.500V
 90 DEG=+0.500V

ANGLE SIGNAL
 0 DEG=-3.125V
 45 DEG=-2.500V
 90 DEG=-1.875V

- 1 OUTER SHIELD GROUNDED AT STRAIN RELIEF CONNECTOR
- 2 INSULATED WIRE SOLDERED TO INNER SHIELD AND CONNECTED AS SHOWN
- 3 INNER SHIELD CUT OFF AND TAPED
- 4 OUTER SHIELD CUT OFF AND TAPED

NOTE:
 MAX. LENGTH SIGNAL
 VARIES WITH BOOM
 MAX. VOLTAGE -4.5V IS
 FOR 10 TURNS ON POT.

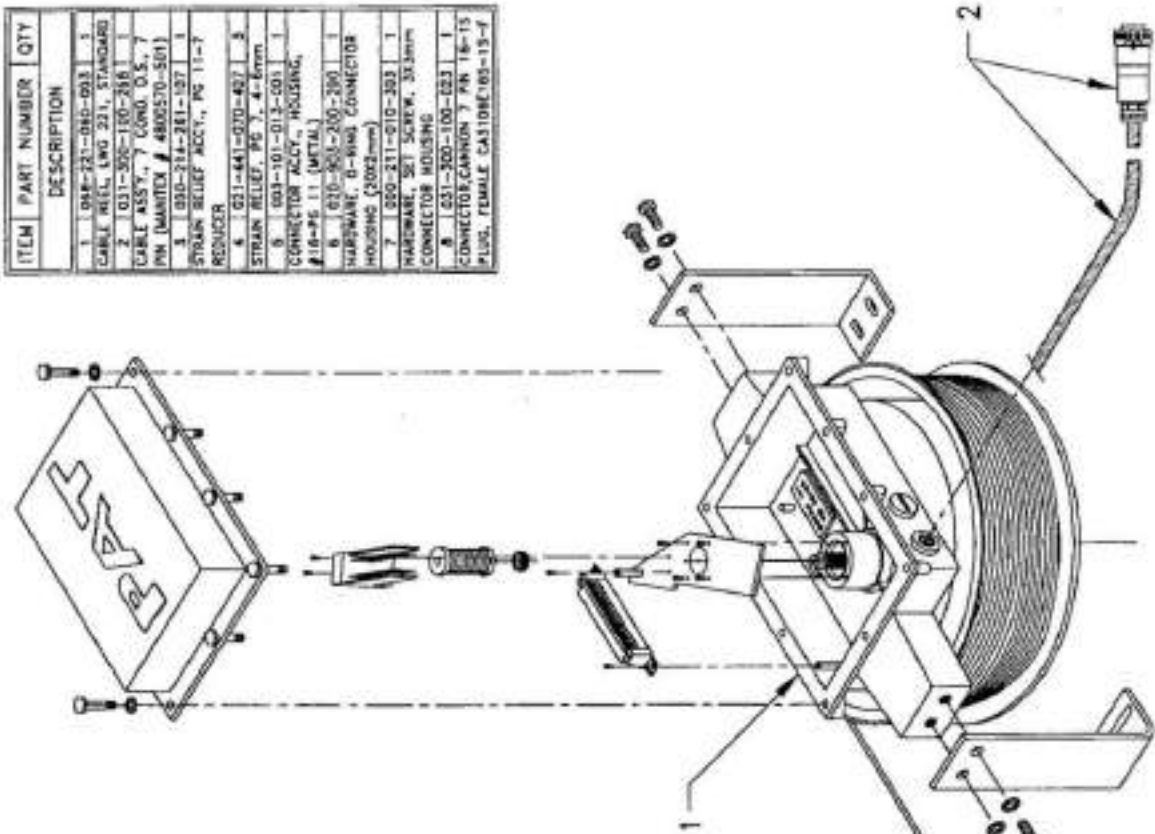
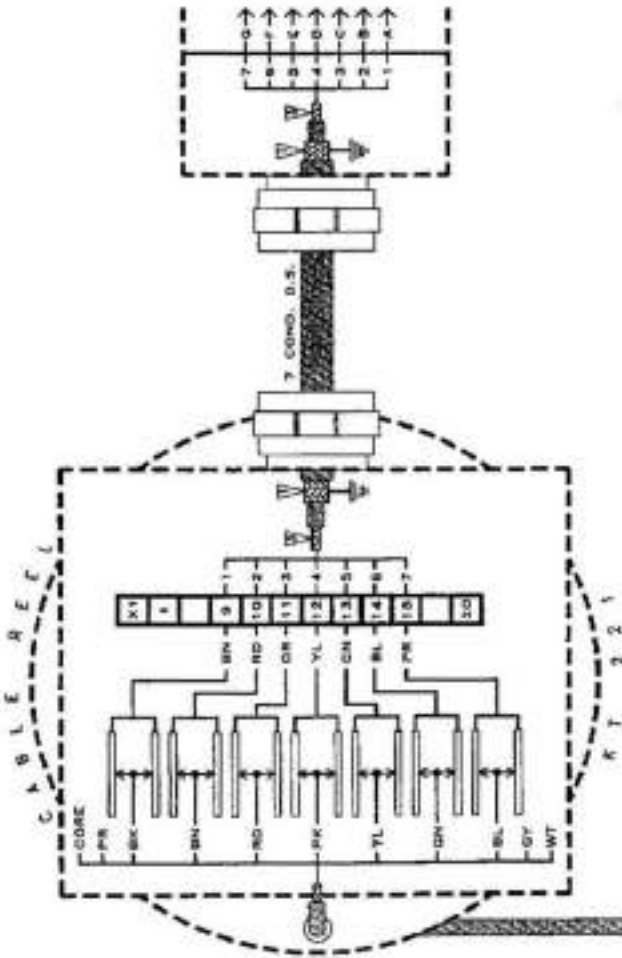
ITEM	PART NUMBER	QTY
DESCRIPTION		
1	046-23-040-003	1
CABLE REL. LNO 231, STANDARD		
2	031-202-100-286	1
CABLE ASSY, 7 COND. O.S., 7		
PIN (MANTIX # 480570-501)		
3	030-214-281-107	1
STRAIN RELIEF ACCT., PG 11-7		
REDUCER		
4	021-441-070-407	3
STRAIN RELIEF, PG 7, 4-6mm		
5	003-101-013-001	1
CONNECTOR ALLOY, HOUSING, #18-PS 11 (MPTA.)		
6	010-303-200-200	1
HARDWARE, 8-RING CONNECTOR HOUSING (3002mm)		
7	020-211-010-303	1
HARDWARE, SET SCREW, 3.5mm		
CONNECTOR HOUSING		
8	021-202-100-023	1
CONNECTOR-CANNON 7 PIN 18-15 PLUG, FEMALE CASTORBE-03-15-F

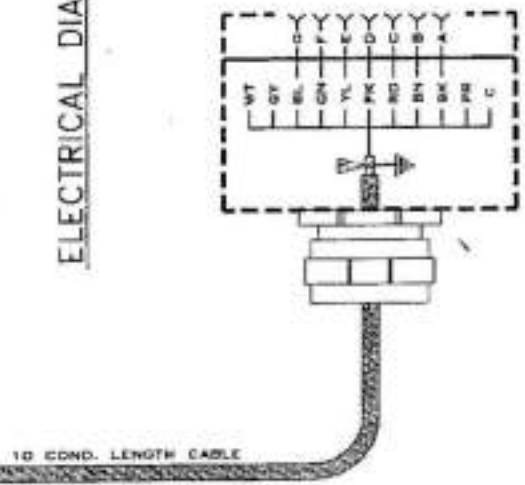
ELECTRICAL DIAGRAM

- NOTES: ELECTRICAL**
- 1. OUTER SHIELD GROUNDED AT STRAIN RELIEF CONNECTOR.
 - 2. INNER SHIELD CUT OFF AND TAPED.
 - 3. SHIELD SHIELD GROUNDED AT STRAIN RELIEF CONNECTOR.

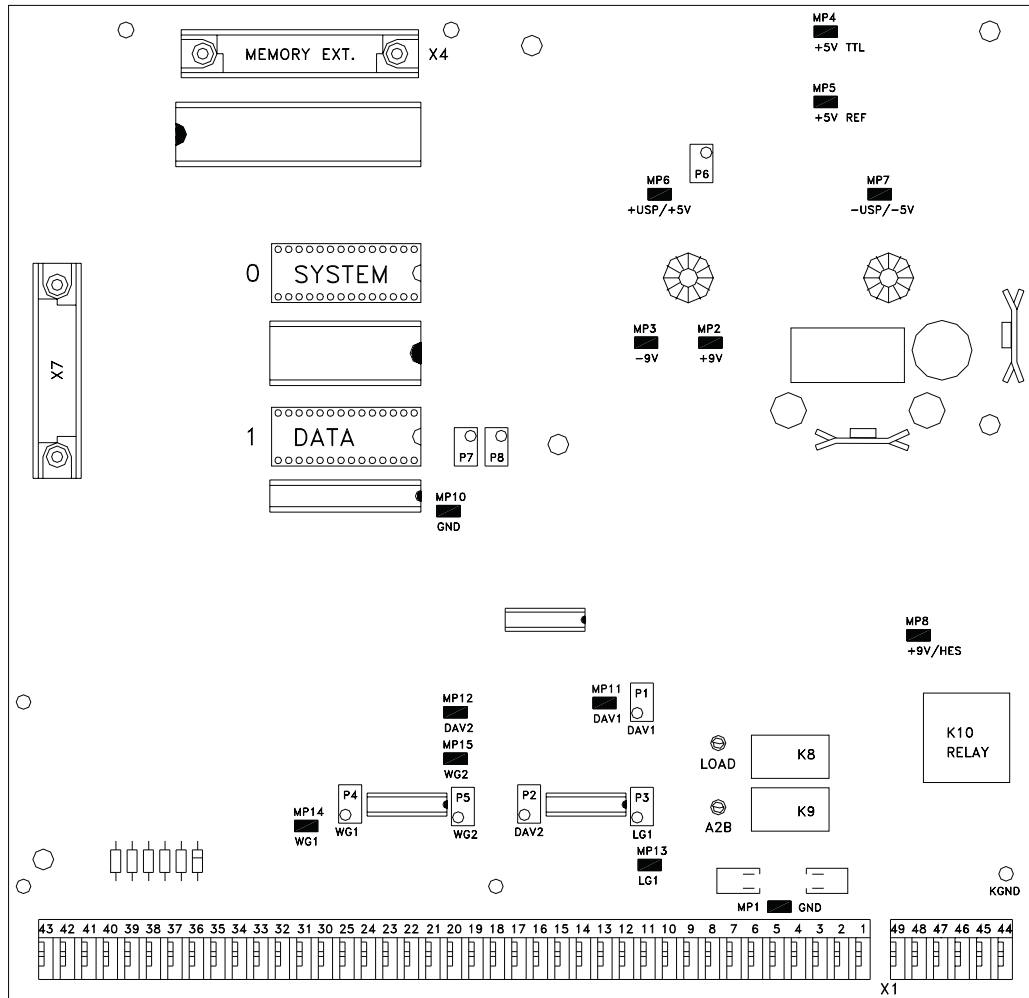
Measuring Points

- MP1: AGND
- MP2: +9V
- MP3: -9V
- MP4: 5V TTL
- MP5: 5V REF
- MP6: +5V/+UPS sensors supply
- MP7: -5V/-UPS sensors supply
- MP8: +9V HES
- MP10: AGND
- MP11: DAV1 piston pressure signal
- MP12: DAV2 rod pressure signal
- MP13: LW1 length signal
- MP14: WG1 angle signal #1
- MP15: WG2 angle signal #2

- LOAD: Overload relay ON(energized/normal conditions)/OFF (de-energized)
- A2B: A2B relay ON(energized/normal conditions)/OFF (de-energized)

1. Lower boom all the way down (no rest pressure) then disconnect hydraulic hose from the piston side pressure transducer.
2. Connect a digital voltmeter to main board
 - A) black (-) lead to mp10
 - B) red (+) lead to mp11
3. Adjust P1 to obtain a reading of 0.500 volts (500mv) on meter.
4. Disconnect hydraulic hose from the rod side pressure transducer.
5. Connect a digital voltmeter to main board
 - A) BLACK (-) lead to MP10
 - B) RED (+) lead to MP12
6. Adjust P2 to obtain a reading of 0.500 volts (500mv) on meter.
7. Reconnect hydraulic hoses to pressure transducers, and then bleed the air from hydraulic lines.
